report Number: 0000000703627-EN170
Item location: ALMERE
tour date: 18.08.2020
license plate: TD-816-V

Volkswagen Polo;Hatchback;Diesel;Manual;Silver

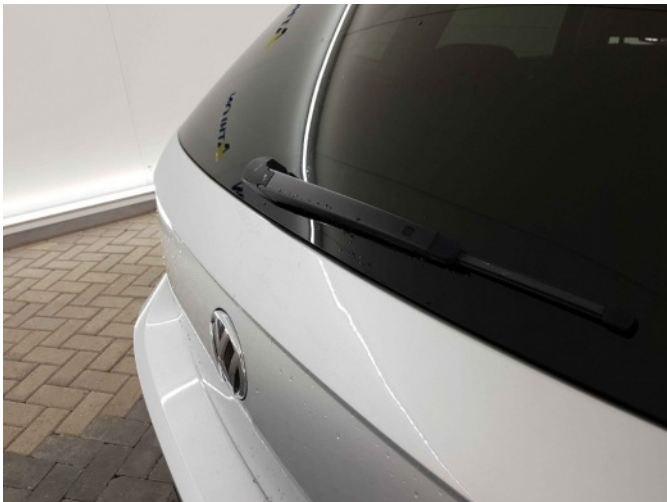
1. Diversen

Wear and tear

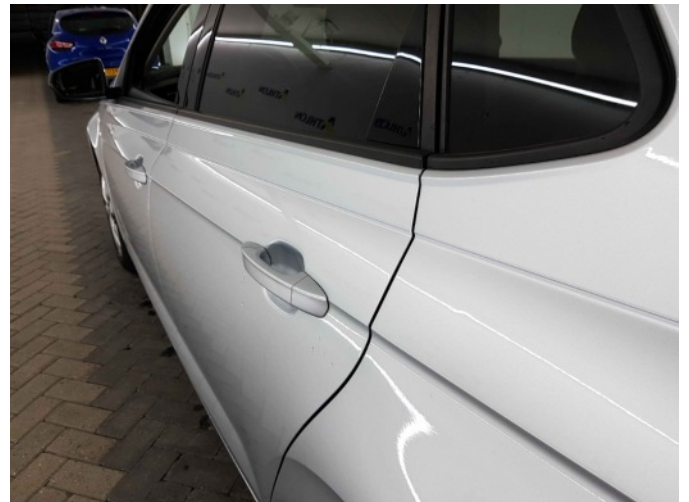
1. Diversen

Wear and tear

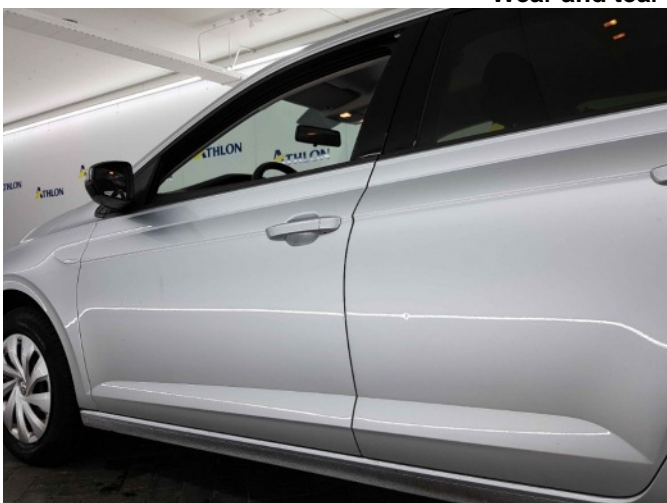
1. Diversen

Wear and tear
