report Number: 0000000658820-EN170

Item location:ALMEREtour date:30.03.2020license plate:RJ-830-F

# BMW i3;Hatchback;Electric;Automatic;

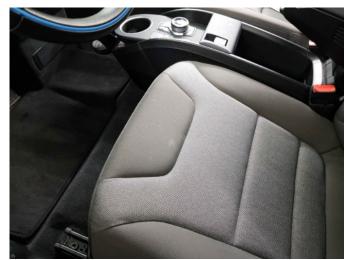
1. Diversen

Wear and tear

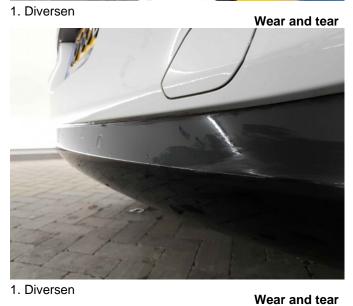
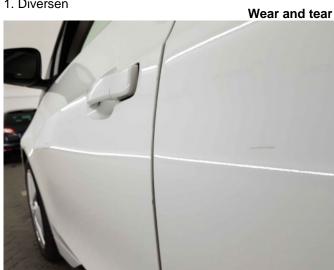
1. Diversen Wear and tear
