report Number: 0000000703627-EN170
Item location: ALMERE
tour date: 18.08.2020
license plate: TD-816-V

Volkswagen Polo;Hatchback;Diesel;Manual;Silver

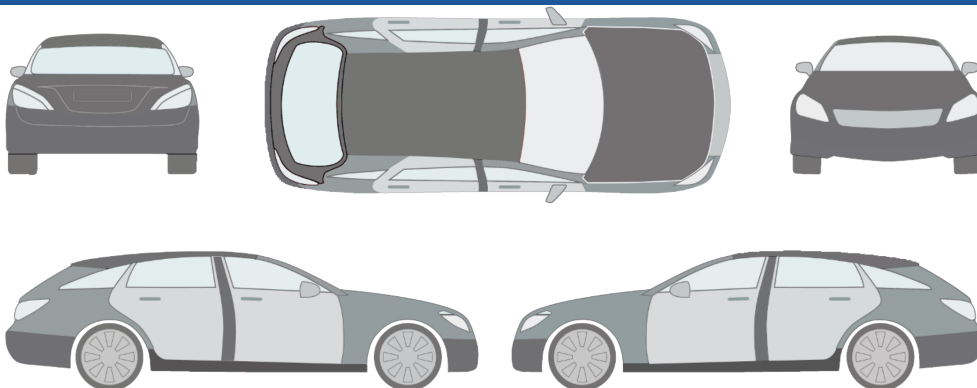
1.) Diversen | Wear and tear

oil loss: in order; instrument cluster: in order; brake system: in order; coupling: in order; engine running: in order; shock absorber: in order; steering test: in Order; transmission: in order; Condition Inside: 2 - Good;
