report Number: 0000000658820-EN170

Item location:ALMEREtour date:30.03.2020license plate:RJ-830-F

# BMW i3;Hatchback;Electric;Automatic;

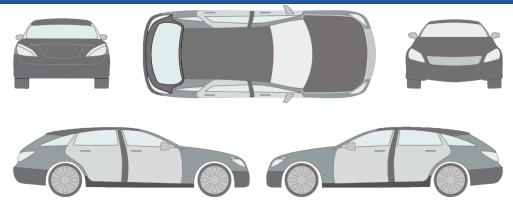
# 1.) Diversen | Wear and tear

oil loss: in order; instrument cluster: in order; brake system: in order; coupling: in order; engine running: in order; shock absorber: in order; steering test: in Order; transmission: in order; Condition Inside: 2 - Good;
